GENERAL ELECTRIC PETERBOROUGH ARMATURE DEPARTMENT #7

DEPARTMENT WIDE RETROSPECTIVE EXPOSURE PROFILE

OHCOW FILE # G884

DATE: JANUARY 30TH, 2006 FINAL EDITION

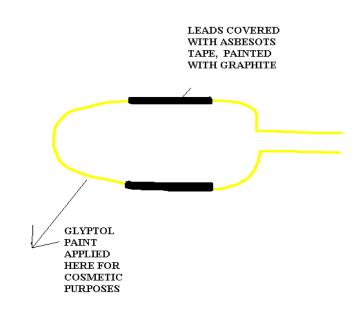
The asbestos tape came in an inch wide reel, with loose fibres. The asbestos tape was held secured with the graphite paint. The rest of the wire was painted with red Glyptol paint. See Diagram 5.

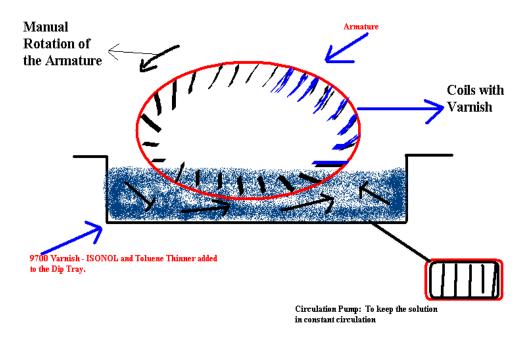
Dipping Armature Coils in Isonol Solution before Heating

employees applied the toluene thinner by 5-gallon safety cans. There was no ventilation over top the drip tray. The employees were subject to the fumes emitted by the reaction of toluene and Isonel mixture, which was circulating by an electric pump. There were approximately 150-180 gallons of varnish in the tray as well. The toluene thinner was added according to the specifications (there was a viscosity chart that the employees had to follow) the employees were given. Approximately 20 gallons of thinner was added to 150-180 gallons of Isonel Varnish. This part of the process would take approximately 10 minutes, i.e. to set up the drip tray.

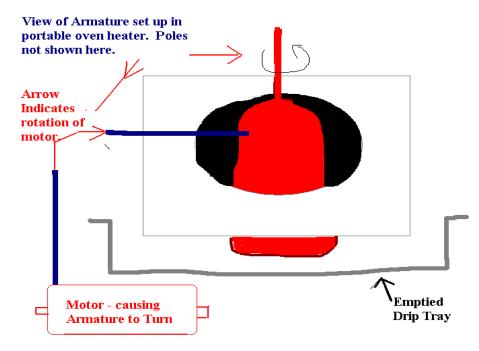
The employees then took the asbestos roll from the dolly. A bar was placed under the blanket and a crane operator would help facilitate the process. Scissors or a knife would be utilized to cut the blanket to the size of the equipment. All sides, top to bottom, were covered /skirted with asbestos blankets to absorb the heat.

The employees state that they did not wear any respiratory equipment, or other forms of PPE for protection again the asbestos or the varnish. They had their street clothes on and would go home with these clothes as well. The asbestos blanket would be draped over the equipment from left to right and back to front. A stepladder was utilized to get over the shaft and folded over the asbestos blanket away from the circular part of the armature. This was also a high fibre process as the blanket was being handled, folded over, and cut to length manipulated etc. Thus the employees were quite intimately interfacing with it and thus being exposed to high levels of asbestos fibres.

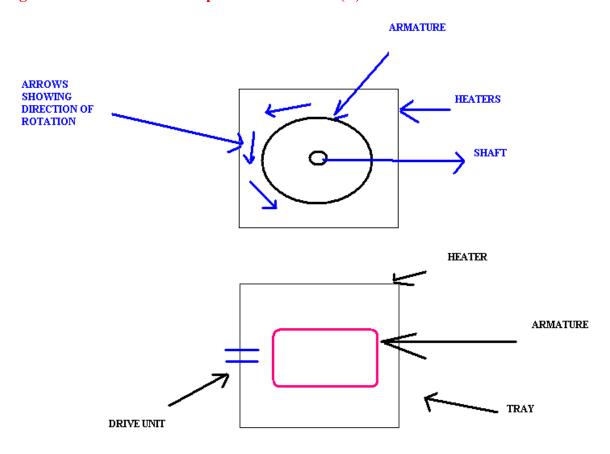
Diagram #11 – Armature Set up in Portable Oven (B)

A wire was also secured over top the asbestos blankets to further secure the blankets to the part and ensure heat would stay within the enclosure.

The blankets were 36 inches wide, no matter what the length. When the employees completed their tasks, they would fold up the blankets. About 15 to 20 blankets were used a year and reused thereafter.

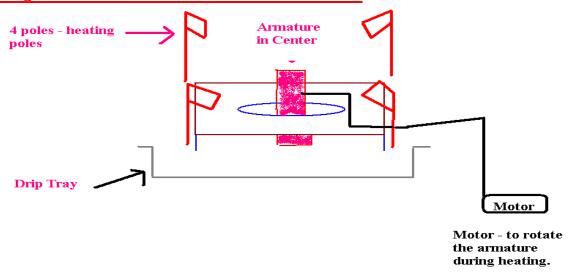
Diagram #12 - Full View of Armature Portable Oven

After the heating had started, the employees would have to monitor and gauge the temperature of the equipment with the use of thermocouples. These gauges would be clipped on to the Armature wires and the temperature would be recorded. This step took place every half hour to monitor the equipment temperature. In order to get the reading, the employees would have to climb at the side of the equipment, move some of the asbestos blankets out of the way so they could climb in and take a reading. Due to the fumes, heat and asbestos fibres, the employees had to do this task very quickly. They would get covered with asbestos fibres due to the movement of the blankets and the crawling between the blankets to get the readings. The varnish had to be at 160 degrees C to ensure a proper cure for baking on the armature. There were 6-8 switches that were required to be turned on or off with regards to the temperature regulations for the portable heater, with a 20-30-degree range.

To stabilize the temperature of the armature it took approximately 12 to 24 hours of heating. After this time, when the heating had stabilized to the desired temperature, the armature was heated further for another 6-8 hours. After this was completed, the armature was allowed to cool with the removal of the asbestos sheets. As per the employees, this process is quite fibrous as the removal of the asbestos sheets caused the frayed, loosened fibres to free float. The employees would get the asbestos fibres on their skin and clothes. The armature was allowed to cool down so that the varnish fumes would dissipate.

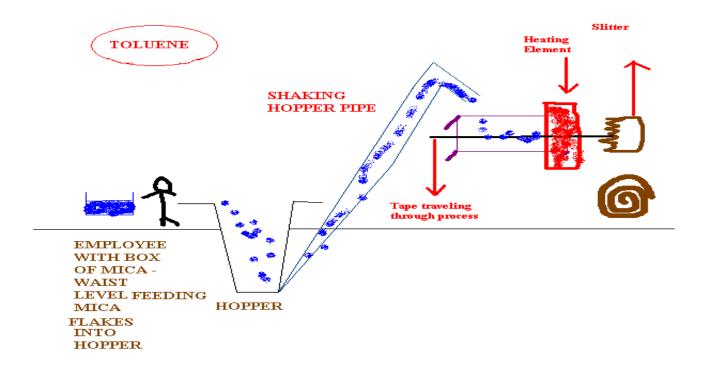
Diagram #13- MICA AREA

- ➤ Mica dust would be flying everywhere
- Employees did wear a face shield, with cotton mask
- The grinding would take place in the ovens, where mica dusts, shellac would be grinded.

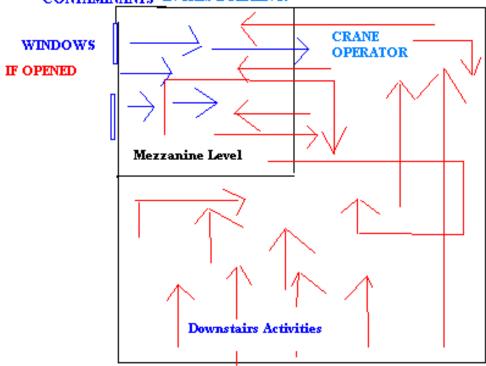
DIAGRAM #14A – MOVEMENT OF CONTAMINANTS IN ARMATURE:

VIEW OF MOVEMENT OF CONTAMINANTS FROM THE FLOOR LEVEL ACTIVITIES, AND THE MEZZANINE LEVEL ACTIVITIES. THE CRANE OPERATORS WERE AT A VERY VULNERABLE LOCATION WITH REGARDS TO THE FLOW OF CONTAMINANTS: IN THIS BUIDLING.

Cross Section of the Building. Arrows indicate flow of contaminants.

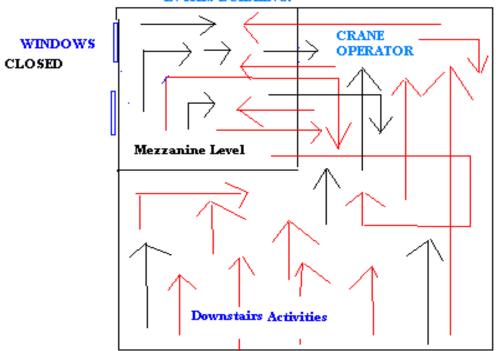
DIAGRAM #14B – MOVEMENT OF CONTAMINANTS IN ARMATURE

VIEW OF MOVEMENT OF CONTAMINANTS FROM THE FLOOR LEVEL ACTIVITIES, AND THE MEZZANINE LEVEL ACTIVITIES, THE CRANE OPERATORS WERE AT A VERY VULNERABLE LOCATION WITH REGARDS TO THE FLOW OF CONTAMINANTS IN THIS BUIDLING.

Cross Section of the Building. Arrows indicate flow of contaminants

As per the diagrams above, when the windows were opened, the contaminants would be pushed toward the lower levels of the armature building (depending on wind direction as well). The pedestal fans would also cause a similar pattern in terms of the flow of air. Moreover, when the windows were closed, the contaminants would be trapped within the building and would have nowhere to be released to the outdoors. All employees would be subject to the accumulation of the fumes, vapours, dusts and other contaminants, including the crane operators who would be subject to this accumulation of contaminants as well. The crane operators wore no protection and their cabins were also not ventilated.

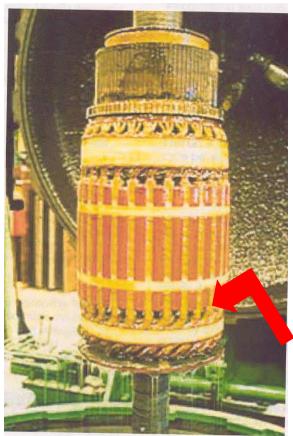
Picture #7: Manufactured Part taken out of VPI Tank - Note: Formation of icicles.

Furthermore, exposure during transfer of parts from VPI open Tank to grinding stations or areas to dry, to cure, or travel to and from the oven would also cause exposure to vapours from the tank and the parts themselves as they are drying off and releasing vapors.

The ovens often had seals that would malfunction and would allow the fumes from the baked parts to escape into the work place air and employees would incur exposures. Evidence of this has already been provided in the previous and current sections of this Report.
