DEPARTMENT WIDE RETROSPECTIVE EXPOSURE PROFILE

WIRE AND CABLE DEPARTMENTS: #26, #24, #22

OHCOW FILE # G732

LESLIE PIEKARZ- OHCOW EXECUTIVE DIRECTOR NICK DECARLO – CANADIAN AUTOWORKERS UNION DR. P. JUGNUNDAN - OHCOW PHYSICIAN DR. NOEL KERIN - OHCOW PHYSICIAN DR. ROLAND WONG -OHCOW PHYSICIAN SONIA LAL – MSC. OCCUPATIONAL HYGIENIST/HEALTH AND SAFETY SPECIALIST MARCH 24, 2005 – FINAL REPORT

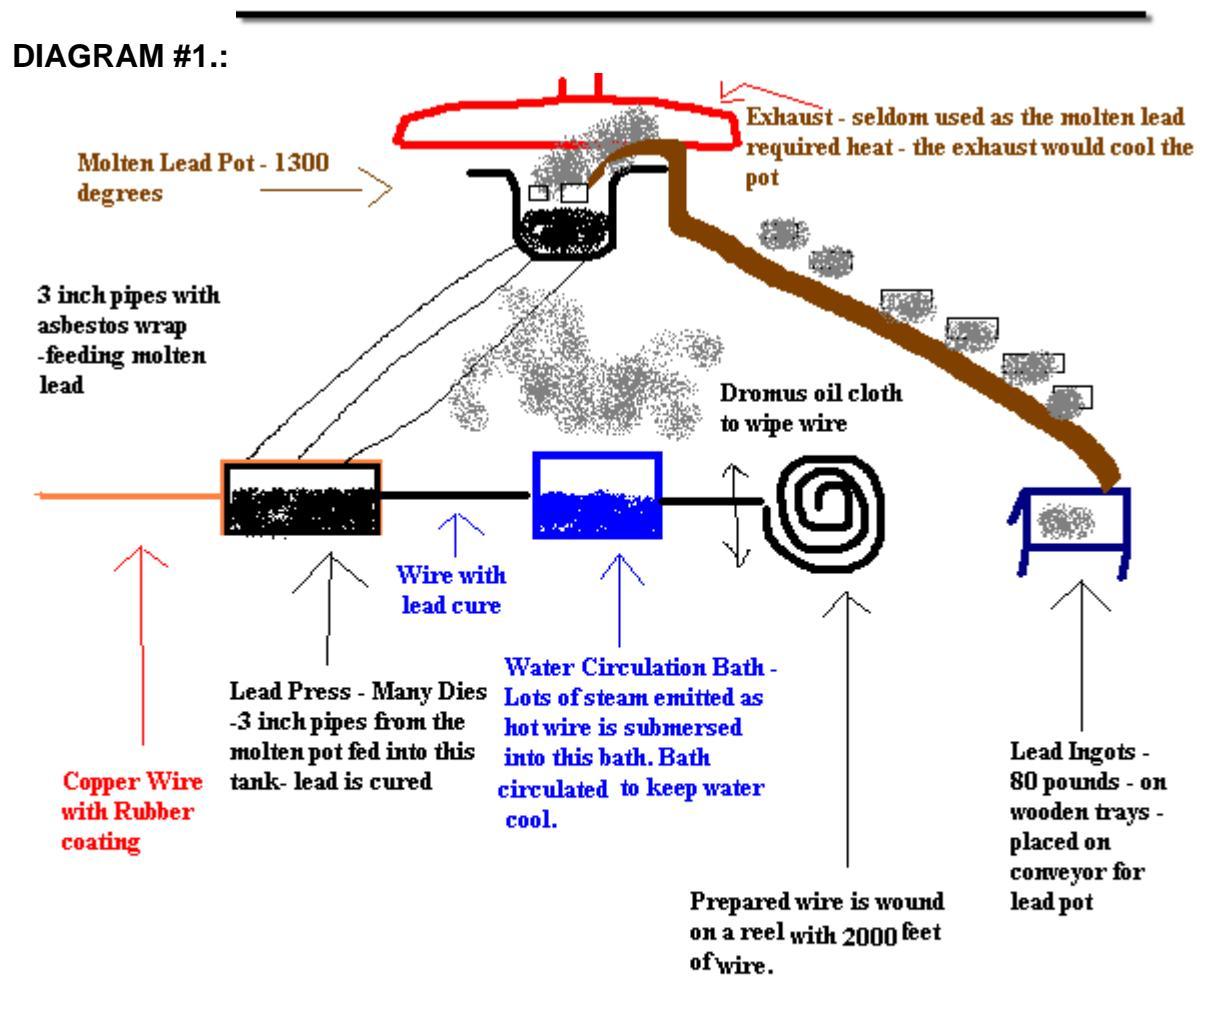
Five-Inch Lead Press:

Some mining cables were required to be coated with lead as well as rubber. This press ran 5-inch wide cable, which was coated with rubber. This operation was run at five feet per minute. The lead that was utilized was recycled lead. Refer to Diagram #1 for further details on this process.

As per the diagram above, the molten lead pot was located 20 feet off the plant floor. The molten lead was heated at approximately 1300 degrees. One employee worked as the press operator while another employee worked as the winder. As per a retired supervisor account, this area was often quite heavy with smoke. The molten lead pot did have an exhaust canopy over it; however, due to the fact that the lead pot required to be heavily heated, the exhaust would not be used due to the cooling effect on the molten lead. The copper wire coated with rubber, would run through the equipment and into a lead press. The lead press had numerous dies in it and as the wire ran through the press, the lead cured onto rubber coated copper wire. The lead press was fed with molten lead via pipes that were connected to the molten lead pot and the lead press. The pipes were 3 inches in width and were wrapped with asbestos, as they were handling molten lead.

The retired supervisor also stated that employees used to eat their lunch and dinner right under the molten lead pot, where they were exposed to lead mists, dust, fumes and mists from the water circulation bath etc. Because the employees ate at their station, they most likely did not wash their hands before ingestion of their food. The retired supervisor also noted that most employees died before they were able to retire.

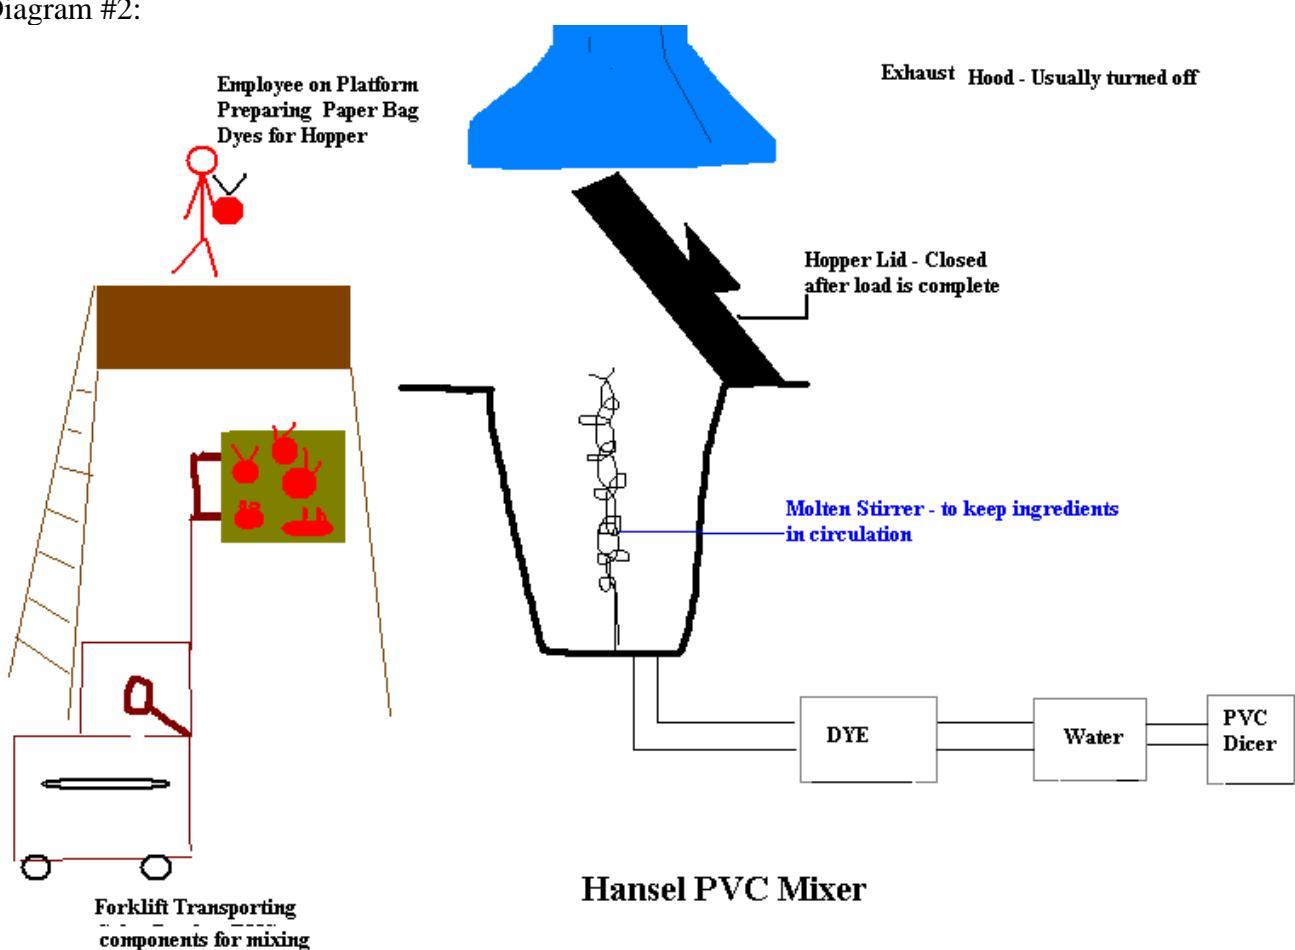
Diagram #2:

Employees would be located at the platform as indicated by the diagram above. At this location they would open the paper bags, which were delivered via forklifts, on pallets. The paper bags consisted of the various ingredients required for the blend and the associated dyes for the type of colour desired. At times, the employees indicated that due to handling or mishandling, the paper bags would be torn or punctured by the forks of the forklift or other means and would cause the ingredients to disperse, thus causing for a very dusty environment. The employee handled the bags by hand. The employees did not wear gloves or safety glasses during this process.

- > There was an exhaust hood present above the hopper. But as per the employees, the exhaust was often turned off.
- > A large spindle was located in the center of the hopper. It acted as a stirrer to keep the ingredients in constant circulation
- > The hopper did have a lid that would be placed over top the hopper once all ingredients were emptied into the hopper.

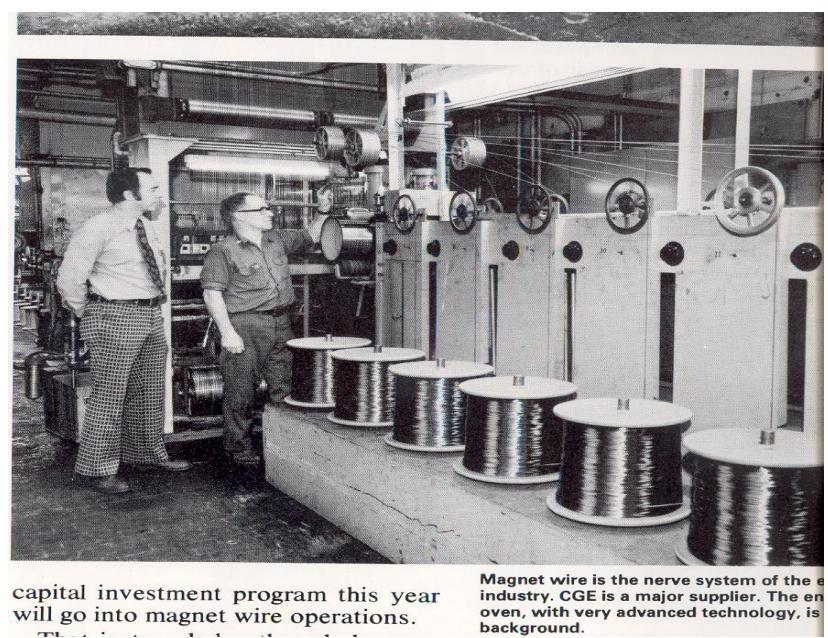
Picture #1 – Formex Process

processes, the employees may go to the platform, 10-12 times per shift, as per the former GE Wire and Cable Supervisor. The sheaves would be cleaned with brushes on the catwalk, for troubleshooting purposes. The sheaves would be cleaned with varsol or acetone. When the acetone would drip down in the oven, the possibility of fire was apparent and this happened on several occasions.

There was an exhaust hood over top the equipment that would be operative as opposed to the other processes discussed. The exhaust was in the form of a water coolant system where the fumes would be captured and fanned off to a Water fall type exhaust absorber. Over top the machinery was a catwalk where employees would monitor/trouble shoot the equipment. The operators would often access the catwalk to perform any repairs that may have been required for the equipment. The operators would often have to access the catwalk anywhere from 1 - 3 times per hour. They did not wear any protection. As already stated in 1970-1972 a government grant was issued to GE and Catalytic burners were purchased

off the front end of the annealer. The supervisor remembers one employee to be overcome to the point where he had incurred a heart attack. Another employee incurred burns. The supervisor stated that the employees that worked in this area died before their retirement and died at an unusually early age.

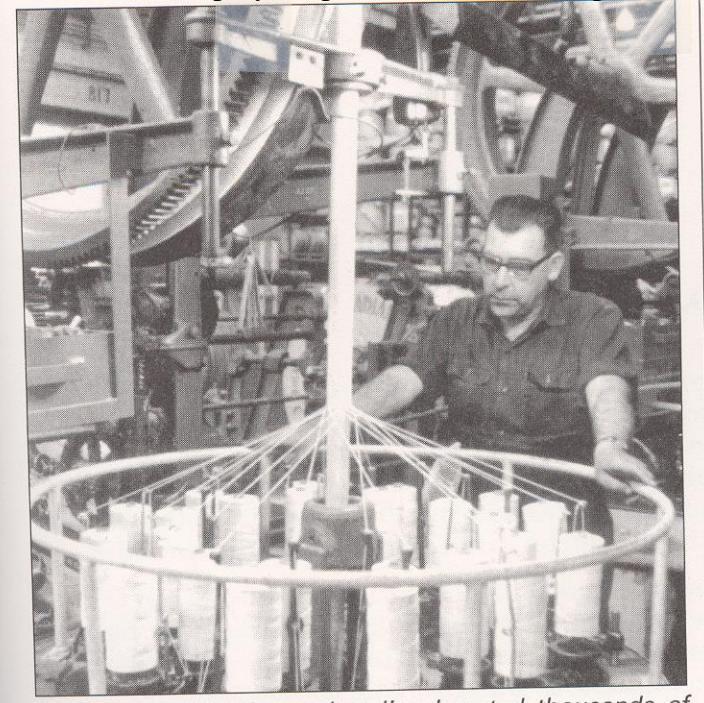
Picture #2 - Braiding Machine:

There were ten employees per shift on 3 shift operations. Eighty Cotton Braiders and eighteen asbestos

braiders were located in this area. This department was very dusty, noisy and fibrous as asbestos was a raw material utilized, machined and handled in this area of Department 22. As per the former GE supervisor, no protection was offered or deemed required for the employees in this area. One Employee was assigned to Twenty six braidex reels. The function of the braiders was to spindle a braid of cotton or asbestos over top of the copper wire, or rubber coated wire or PVC. Sixteen spindles put a braid on top of the wire. The asbestos was first dipped in isopropyl alcohol before it was braided onto the wire so that it would facilitate the travel through the machinery. The employees had a 5-gallon pail they would utilize to dip the asbestos in. After the asbestos was braided it would be rolled onto the reel and then taken to the wax pot for coating. The wax was applied hot and it's purpose was to prevent any fraying of the asbestos braid. The employees would blow the asbestos off the equipment, workbenches and their own clothing and skin via air hoses. This indeed

would cause the fibres to disperse into various locations, and cause them to become airborne and contaminate other areas of the plant. The fact that the employees had to blow off their clothes and equipment with the air hose indicates that the processes caused fibres to disperse into various areas and thus caused exposures to many employees in and around the areas. With the use of air hoses, the fibres were dispersed even more, or became re-suspended in the air and could cuase more exposures. In terms of housekeeping, the employees would sweep the asbestos fibres and dust off the floor. This also caused the fibres to become airborne.

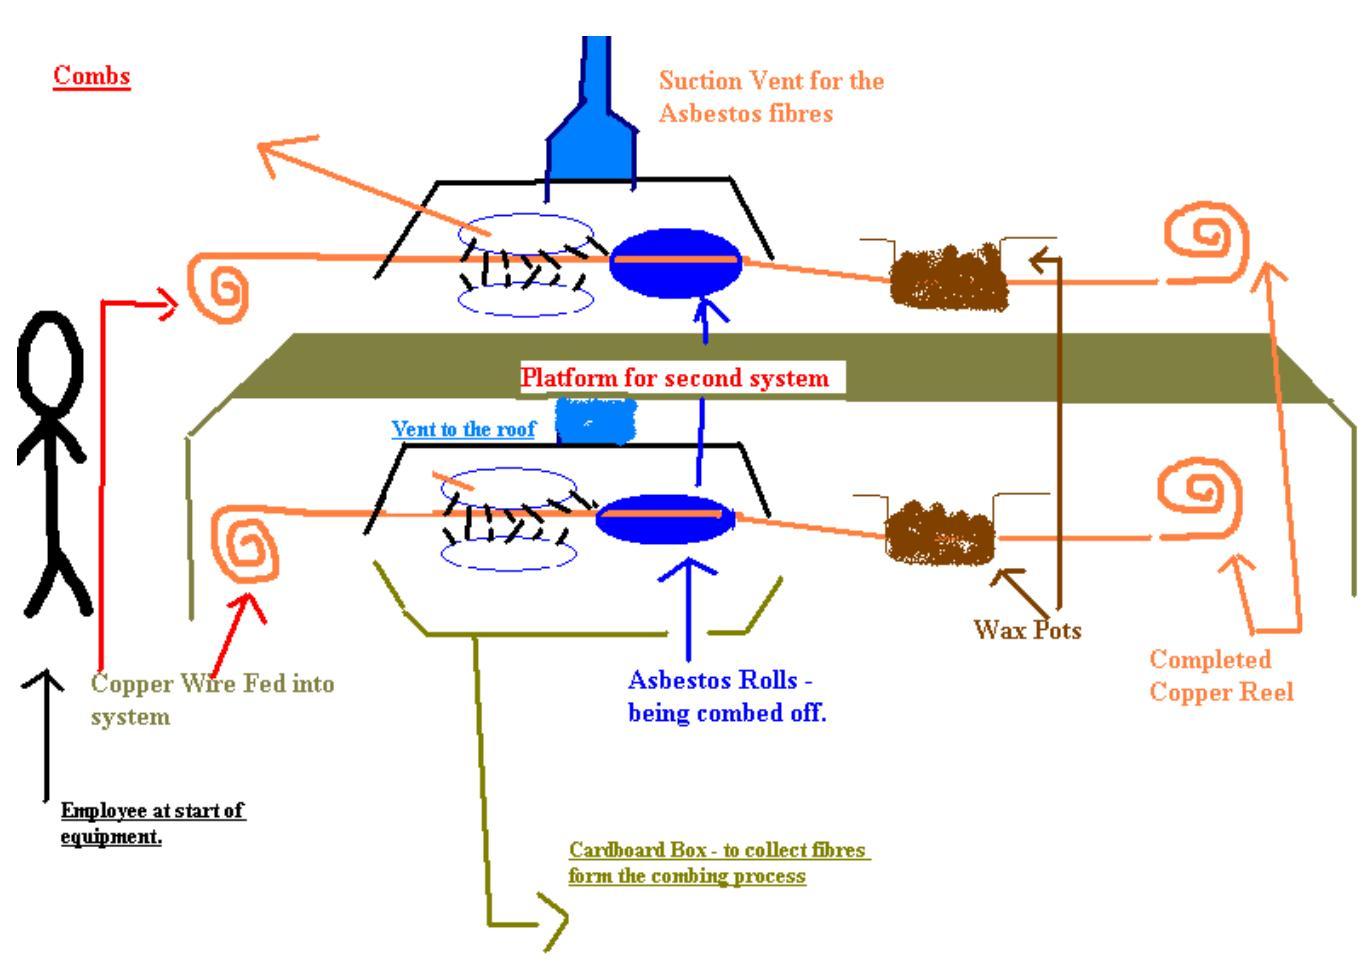
See Diagram #6: Carders

This operation was located south west of the saturating tanks and tar pots. The process was in place from 1945 till approximately 1979. Three people worked in the area and one employee was assigned to the four carding machines. Reel to reel the machines were twenty-five feet in length. The machines were about 5 feet apart. The speed of the wire traveling through was 30-40 feet per minute. The maximum speed was 40 feet per minute. The process was set at different speeds for different types of wire. It is important to note, that the 31 Carding systems were set up like a "bunk bed system" where there were two similar processes running in line with one another, where one of the carders was located on top of the other. As per the Diagram #6 below, the top deck system was set at approximately 6 feet off the floor with the bottom deck system set at 2 feet off the floor. There was a lid that went over top the asbestos roll and combing process, however it was open from the bottom areas; it was not a fully enclosed lid, it acted as a guide for the combing process. With this combing process, the employees state there were a lot of asbestos fibres in the areas, being dispersed by the activities of the carding process, and the general activities in the area (body movement, liftruck activities, pedestrian activities, overhead crane operations, windows opening, pedestal fans etc). The rolls of asbestos would be 5, 8 or 10 inches depending on the amount of insulation required on the wire. A cardboard box was placed beneath the combing process to collect all the fibres. As the boxes were filled, they were either sold to employees or packaged and sent to the salvage areas, as per the former GE supervisor and employee testimonies.

The wax pot was a heated pot. It did not have any exhaust over top of the pot.

The wire was taken off the reel and run through the ball of asbestos. The asbestos was 6 feet in length and was 8 inches wide. Combs run across the balls of asbestos and spread the fibres over top the traveling wire. There was approximately 6 feet of combing required. This part of the carding equipment was exhausted by pipes to the roof into collector bins. The wire was then run through a wax pot and reeled. The wax pot consisted of melted Para film wax sheets. The pipes were exhausted out to the roof into the collector bins. The bin had a divider in the center so as to alleviate the packing of asbestos fibres. There were doors on each side of the bin, so employees could enter and empty the bin.

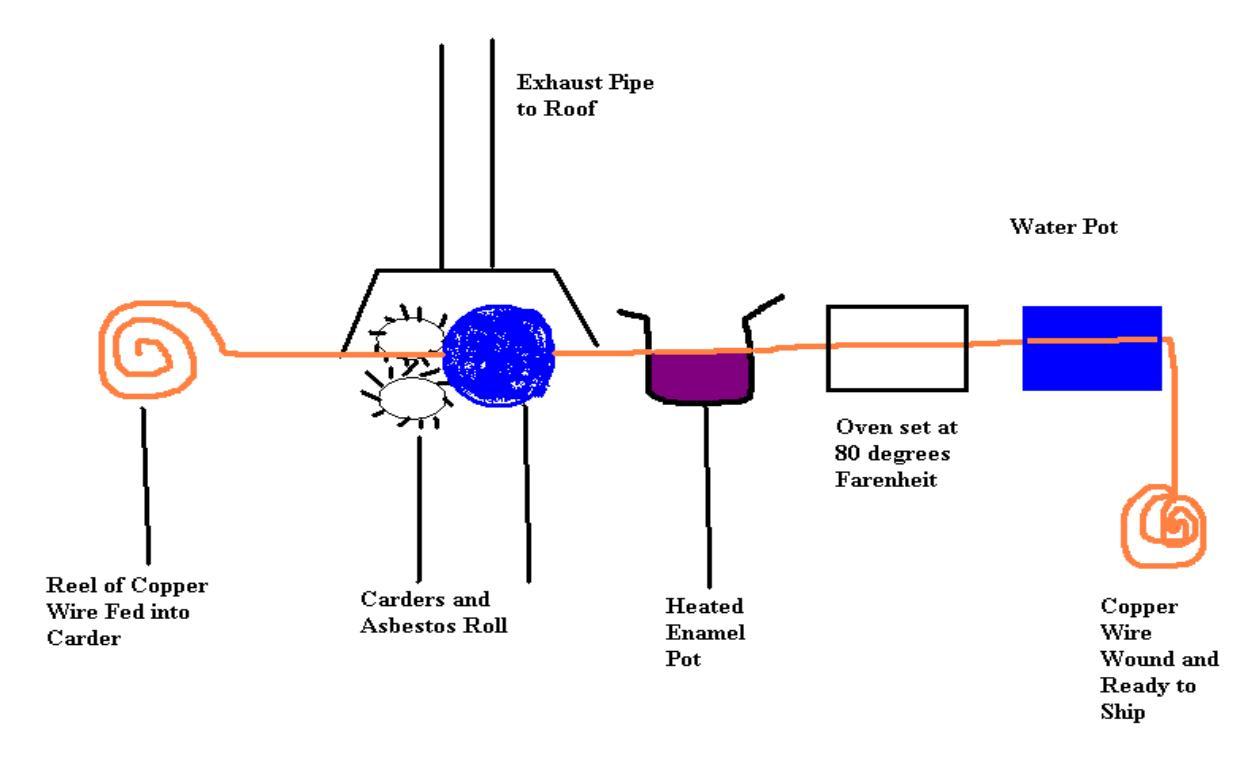
Diagram #7 – AWE Carders (above)

All carders were vented to the roof. The venting pipes were joined, met near the roof top and were then vented out through one vent pipe and out to the bins on the rooftop. All in all there were 6 pipes which joined and then were vented to the roof and joined to the big bin. The bins were 20 feet long and 8 feet high.

This was a continuous process; hence the employee ate at this workstation. The employees wore their street clothes for this process and did not wear any protection in the form of respiratory or glove protection.
