DEPARTMENT WIDE RETROSPECTIVE EXPOSURE PROFILE

WIRE AND CABLE DEPARTMENTS: #26, #24, #22

OHCOW FILE # G732

LESLIE PIEKARZ- OHCOW EXECUTIVE DIRECTOR NICK DECARLO – CANADIAN AUTOWORKERS UNION DR. P. JUGNUNDAN - OHCOW PHYSICIAN DR. NOEL KERIN - OHCOW PHYSICIAN DR. ROLAND WONG -OHCOW PHYSICIAN SONIA LAL – MSC. OCCUPATIONAL HYGIENIST/HEALTH AND SAFETY SPECIALIST MARCH 24, 2005 – FINAL REPORT

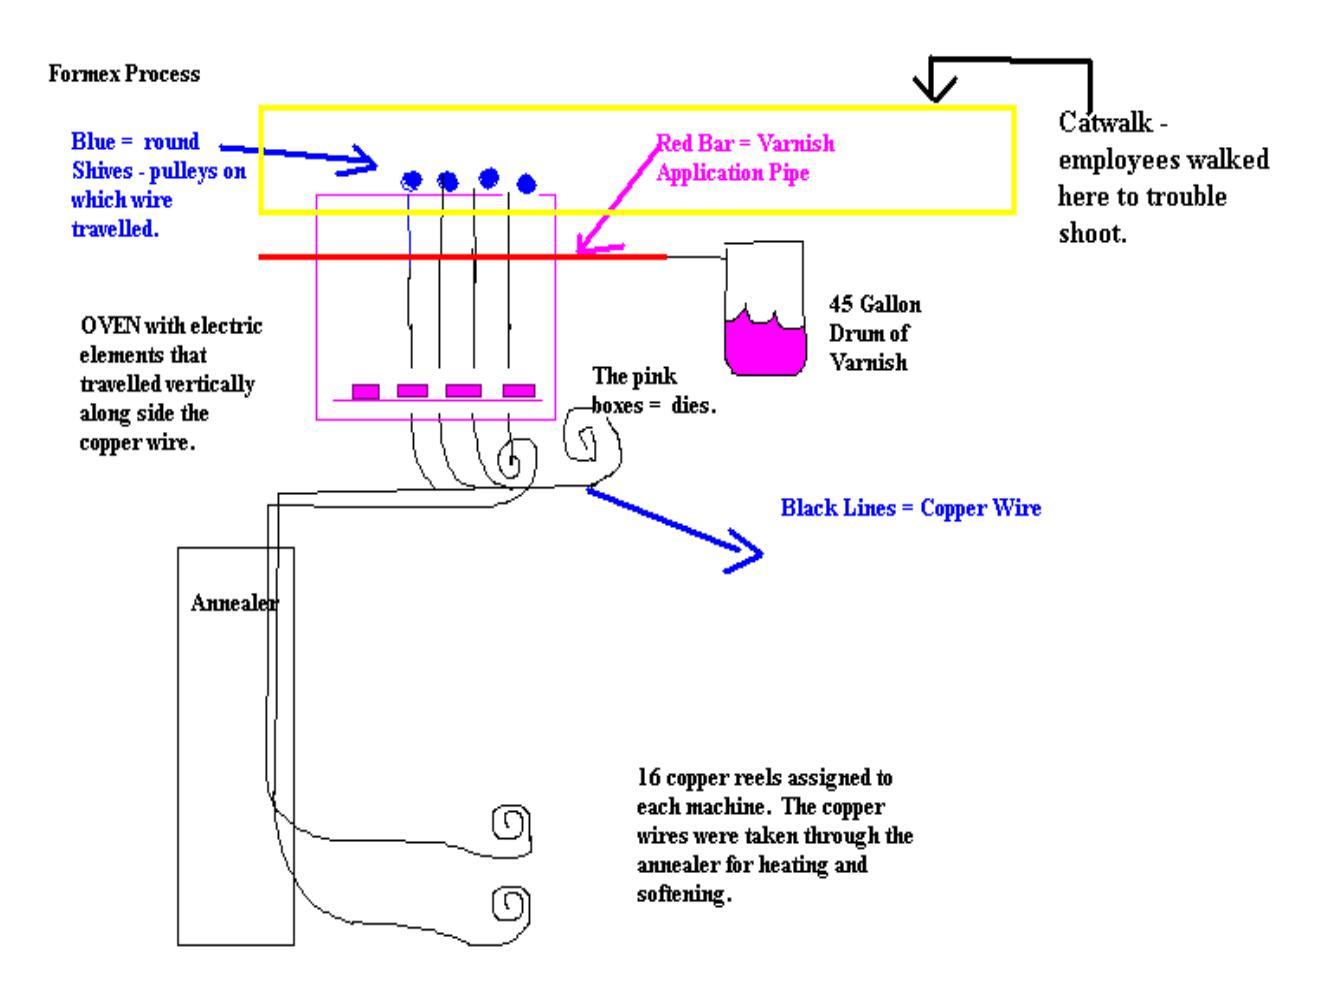
Diagram #3:

The sheaves were like reels or pulleys on which the wire traveled through the ovens. In order to clean the sheaves thoroughly, as they would accumulate layers and layers of varnish, they would be dipped in an acid bath. The tank was 6 x 5 feet in size. The bath was located in the north end of building 24. During troubleshooting purposes, varsol and brushes were utilized to clean the sheaves during regular process operations. The operators would go on the catwalk and attempt to troubleshoot and unclog the accumulation of the varnish. In 1977-78 the acid tank was introduced and the sheaves were allowed to sit in the tank for 5 -6 hours at a time. The tank consisted of cold acid. After the dipping process, the sheaves were pulled up via crane and allowed to drip dry for several hours thereafter. This process would emit heavy vapours off the sheaves as the acid bath was allowed to remain uncovered during this time.

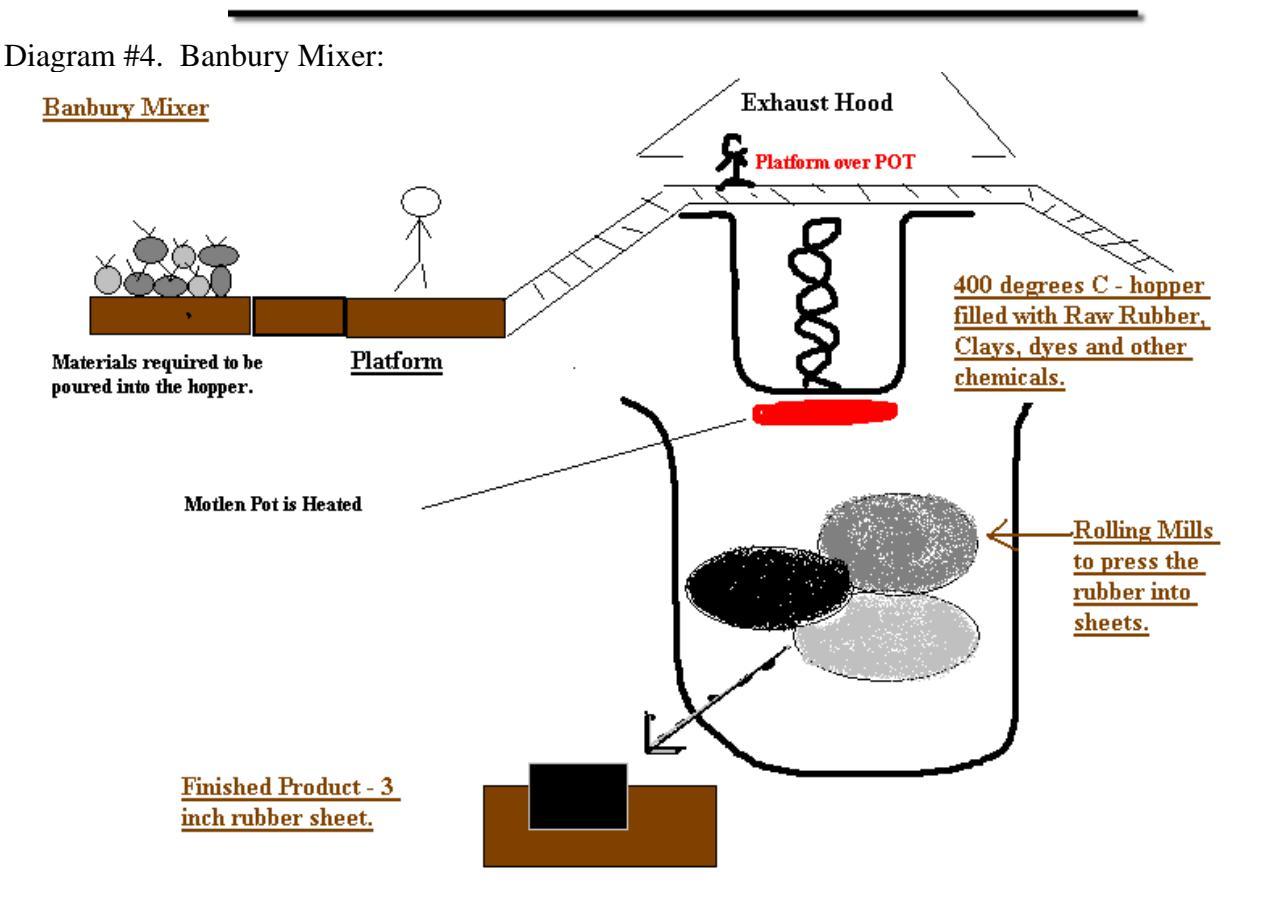
Due to the rubber making process, and all the chemicals, this was a very dusty process as well as heavy in fumes. There were windows present in this area, however, as there was a cafeteria across from the north end of building 22, the GE employees did not allow the banbury mixer employees to open the windows, in fear of being contaminated by the fumes and dust. Hence, there was no fresh air allowed into this area and no where for the contaminated air to be exhausted. The exhaust was not used on a regular basis, as the cooling effect from the exhaust would cause the mixer to work less efficiently.

Fresh air circulation was next to nil as, the opening of windows was not permitted as employees requested the Banbury Operators to keep the windows closed so as to refrain from contaminating the outside air (air would travel to the nearby cafeteria).

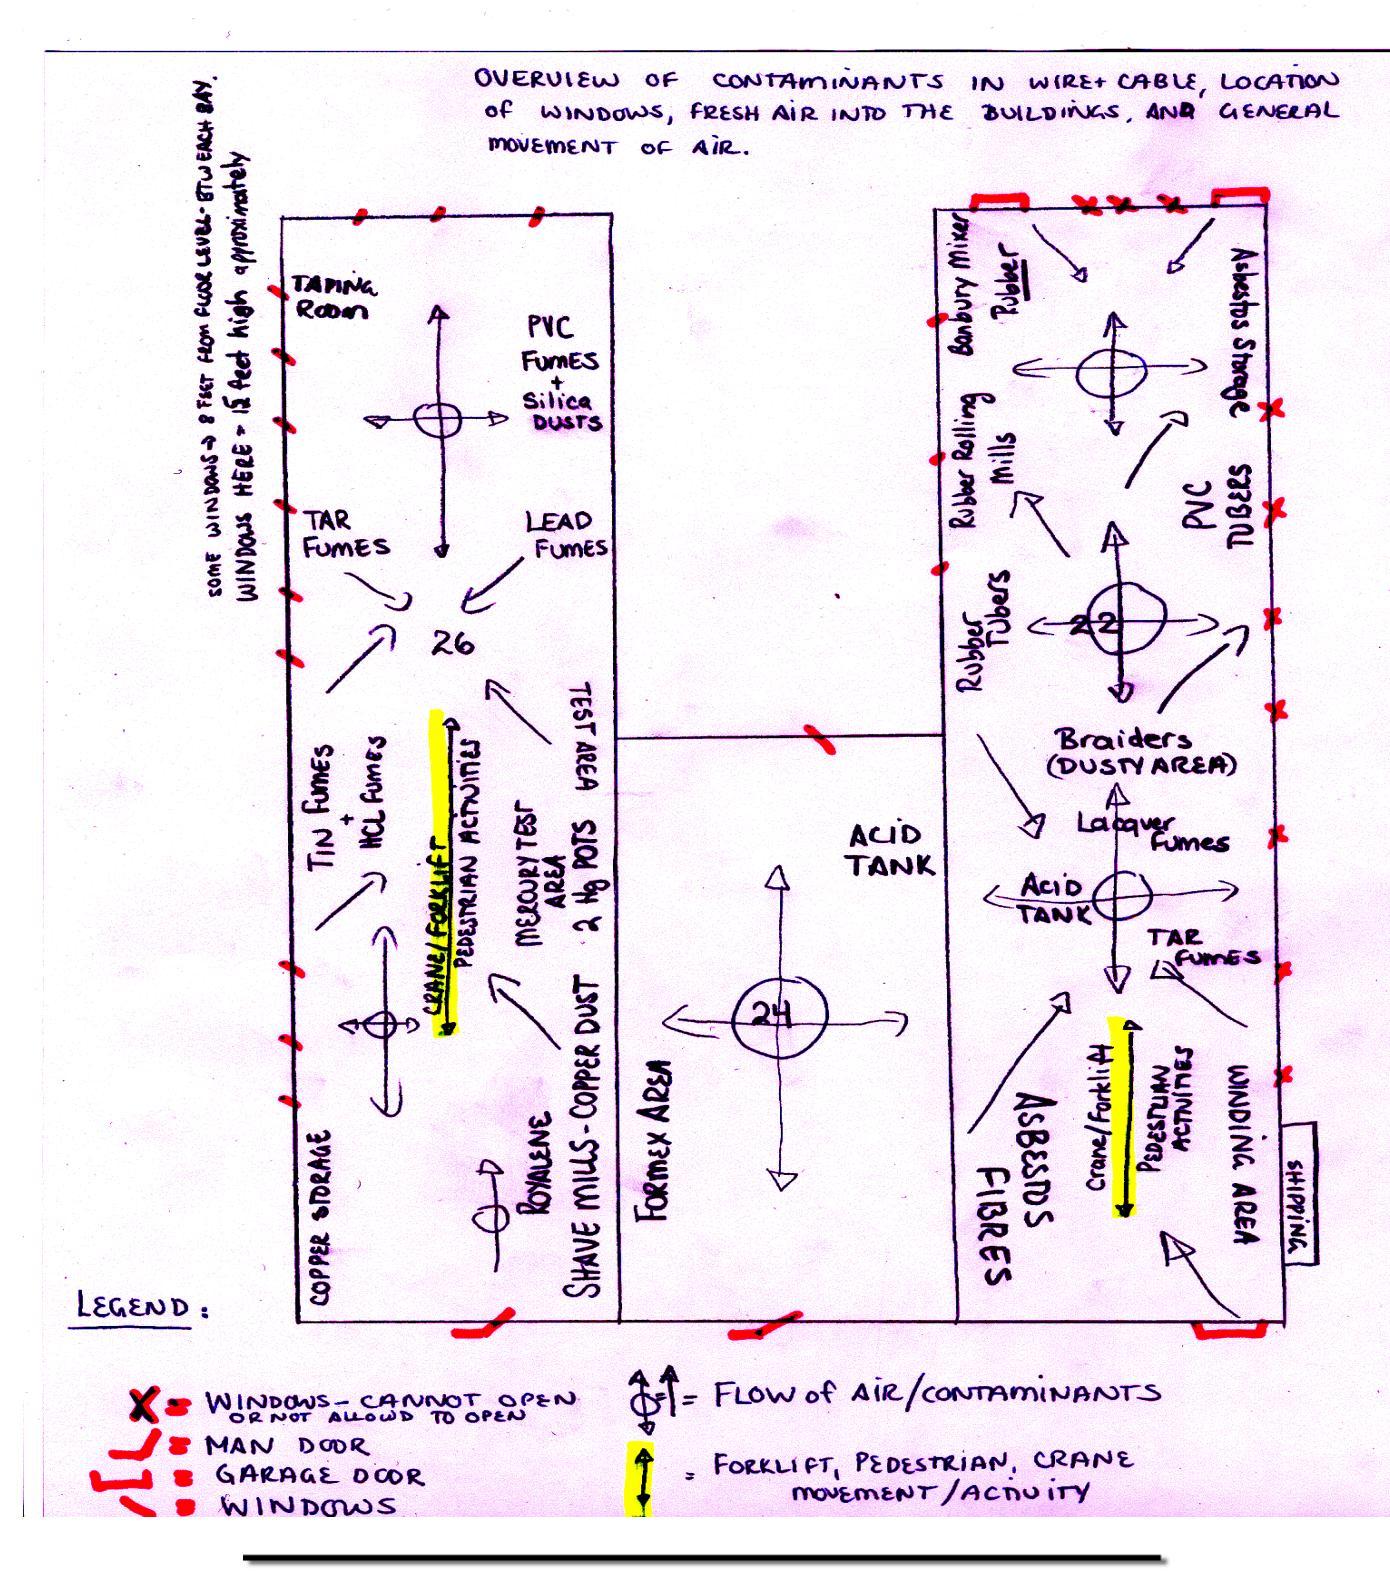
The crane activities in building 22 and 26 would have caused some of the contaminants to move or flow from one area to another, North and South, thus moving the body of air/fumes from one area to another, north to south and vice versa. However, without any proper ventilation, make up air or fresh air, perhaps more in the summer months versus the winter, the contaminants would just accumulates and the employees would be subject to them. Winter exposures could potentially be higher as natural ventilation supplied by open doors and windows is decreased.
